VALVES AND VALVE PROBLEMS

MR. A. PERKINS (MSFC)

FACILITY FORM 602
N 67-19032
(ACCESSION NUMBER)
39
(PAGES)
TM-X-59419
(NASA CR OR TMX OR AD NUMBER)

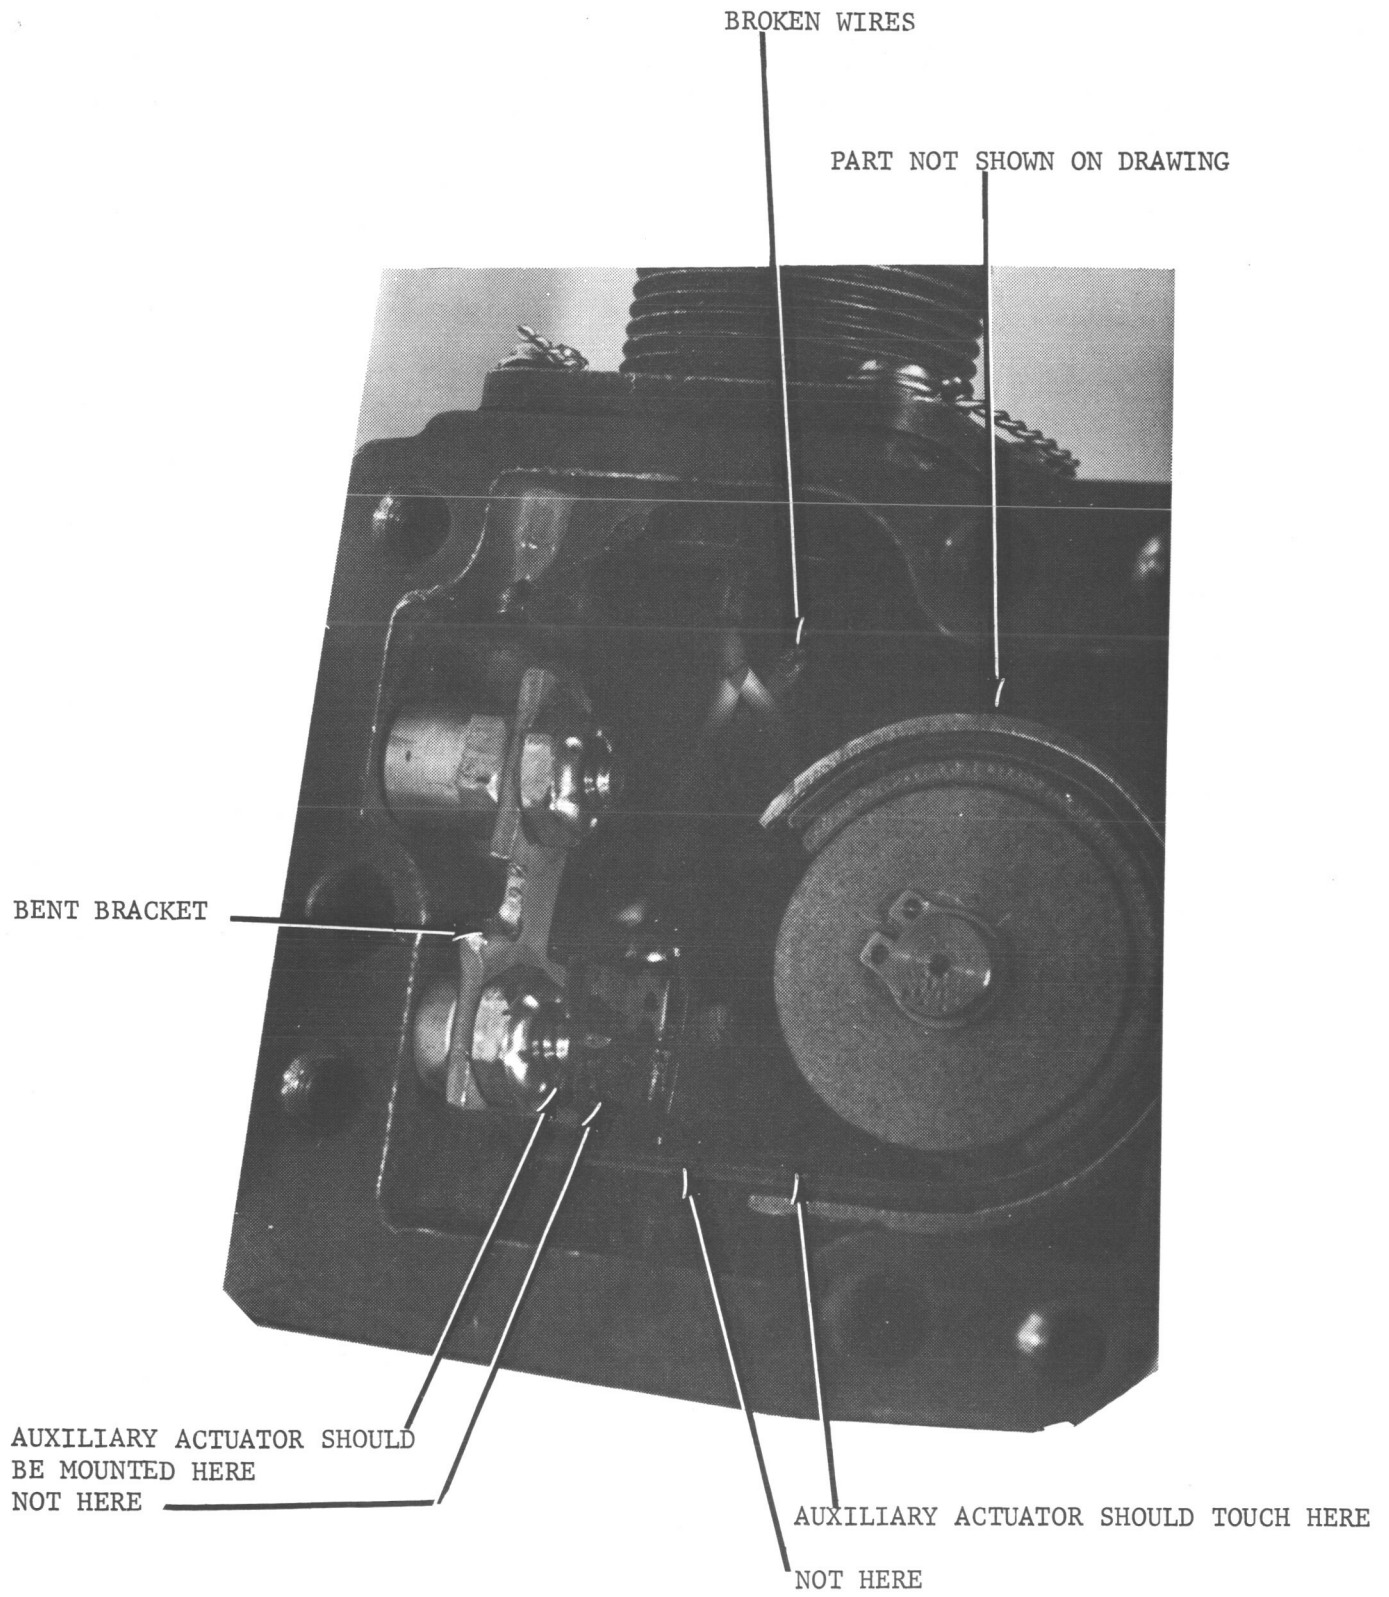
Figures 20 and 21 show the poor quality of two different type pressure switches that had failed on two of the Saturn Vehicles during checkout.

FIGURE 21. DEFECTS IN PRESSURE SWITCH
